# GUANGDONG YOHOME DOOR CO., LTD

AS 1530.4: 2014 Fire Resistance Testing on Single Leaf Single Action Timber Composite Fire Door,  
Model: YHASFD90, When Installed in Plasterboard Partition

241203110GZC-001 R2

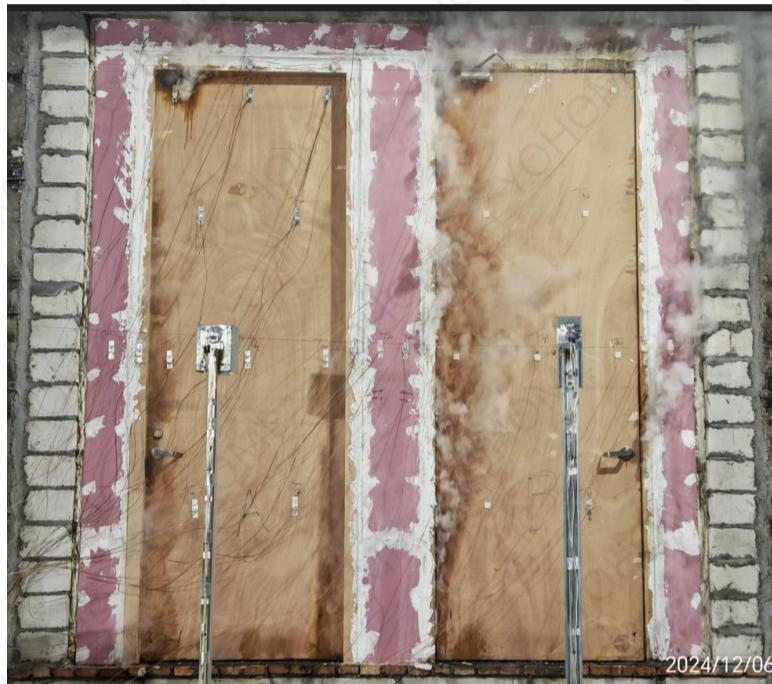
Photo 5 – Unexposed Side after 30 Minutes

| Time | | All observations are from the unexposed face unless noted otherwise. |
|---|---|---|
| 30 | 00 | No integrity failure has occurred. |

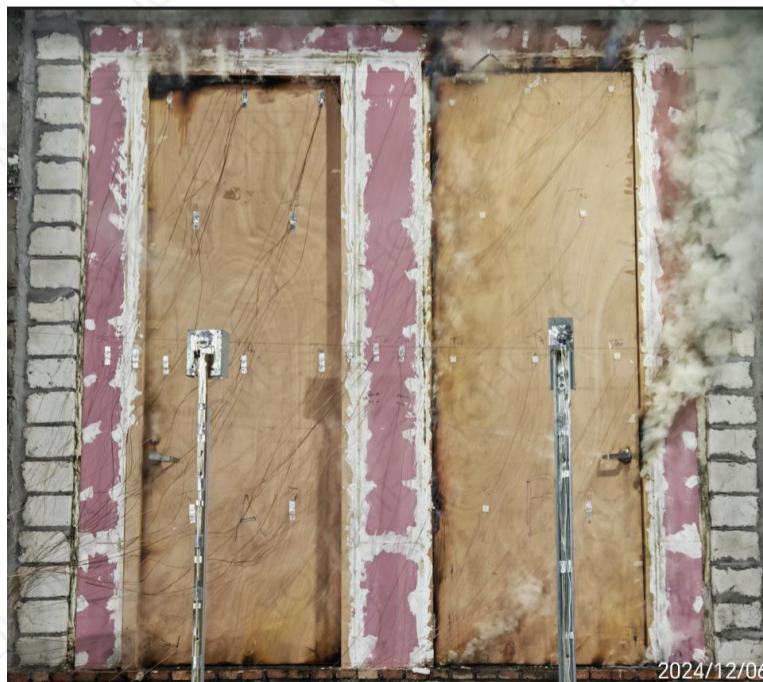
Photo 6 - Unexposed Side after 60 Minutes

| Time | | All observations are from the unexposed face unless noted otherwise. |
|---|---|---|
| 60 | 00 | No integrity failure has occurred. |

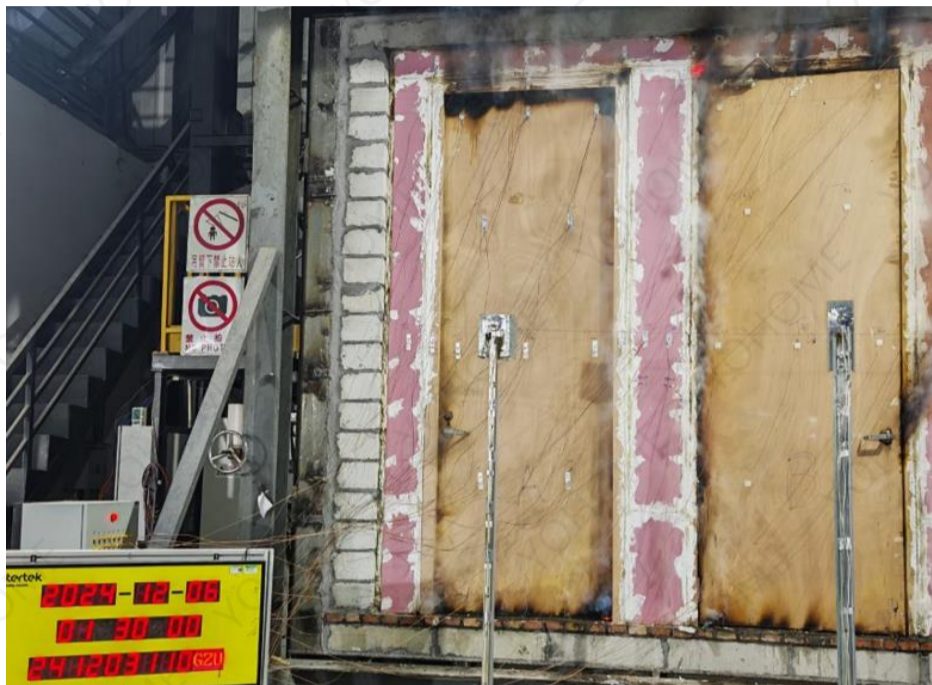
Photo 7 - Unexposed Side after 90 Minutes

No through openings or penetrations were evident at this 90 minutes' fire exposure portion of the test. No cotton pad or significant flaming were observed on the unexposed face of the assembly for 90 minutes. The latching mechanism was visibly engaged.

| Time | | All observations are from the unexposed face unless noted otherwise. |
|---|---|---|
| After Test | | Doorset A, latching mechanism was visibly engaged.<br>Doorset B, latching mechanism was visibly engaged. |
